**PARTIAL**  
**STURAA TEST**  
**12 YEAR**  
**500,000 MILE BUS**  
**from**  
**OPTIMA BUS CORPORATION**  
**MODEL OPUS UNDER 32' LFB**  
**AUGUST 2006**  
**PTI-BT-R0612**

**The Pennsylvania Transportation Institute**

**Bus Testing and Research Center**

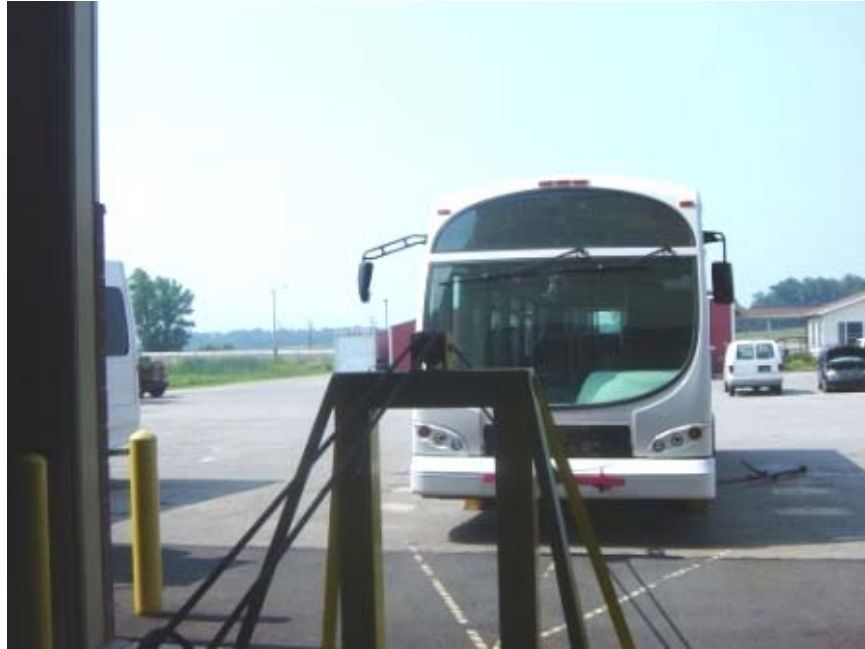
**FRONT 20° UP PULL**

The load-distributing yoke was incorporated as the interface between the Static Tow apparatus and the test bus tow hook/eyes. A front test was performed to the full target test weight of 26,904 lbs (1.2 x 22,420 lbs CW). No damage or deformation was observed during all four pulls of the test. The test bus was not equipped with rear tow eyes or tow hooks, therefore, a rear test was not performed.

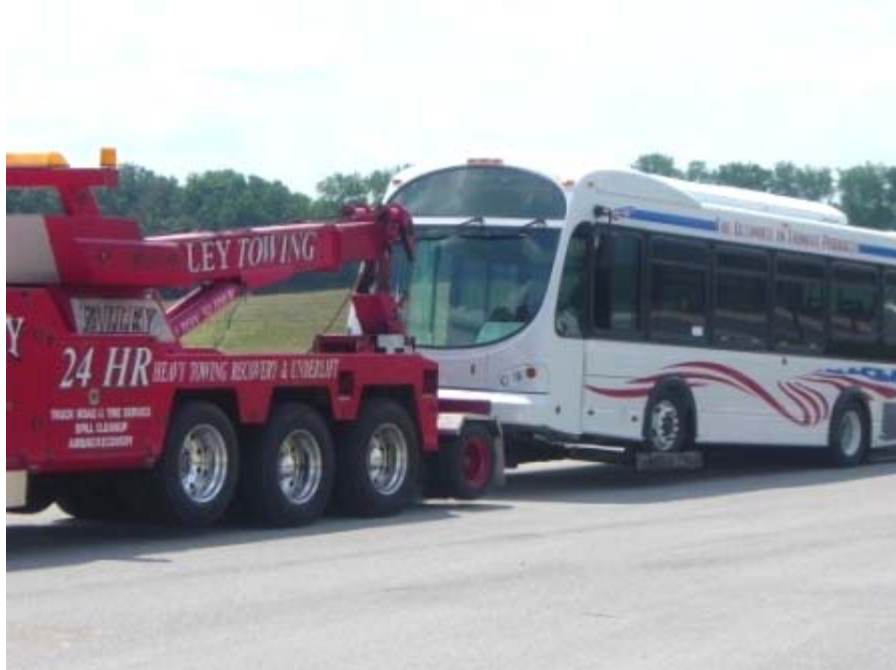
## TOWING INTERFACE

The bus was towed using a heavy-duty wrecker. The towing interface was accomplished by incorporating a hydraulic under lift. A front lift tow was performed. No problems, deformation, or damage was noted during testing. The rear of the test bus was not equipped with tow eyes or tow hooks, therefore, a rear tow was not performed.
