**PARTIAL**  
**STURAA TEST**  
**7 YEAR**  
**200,000 MILE BUS**  
**from**  
**CABLE CAR CONCEPTS**  
**MODEL 208" WB MAXI DIESEL FUELED TROLLEY**

**MAY 2003**  
**PTI-BT-R0306-P**

**The Pennsylvania Transportation Institute**

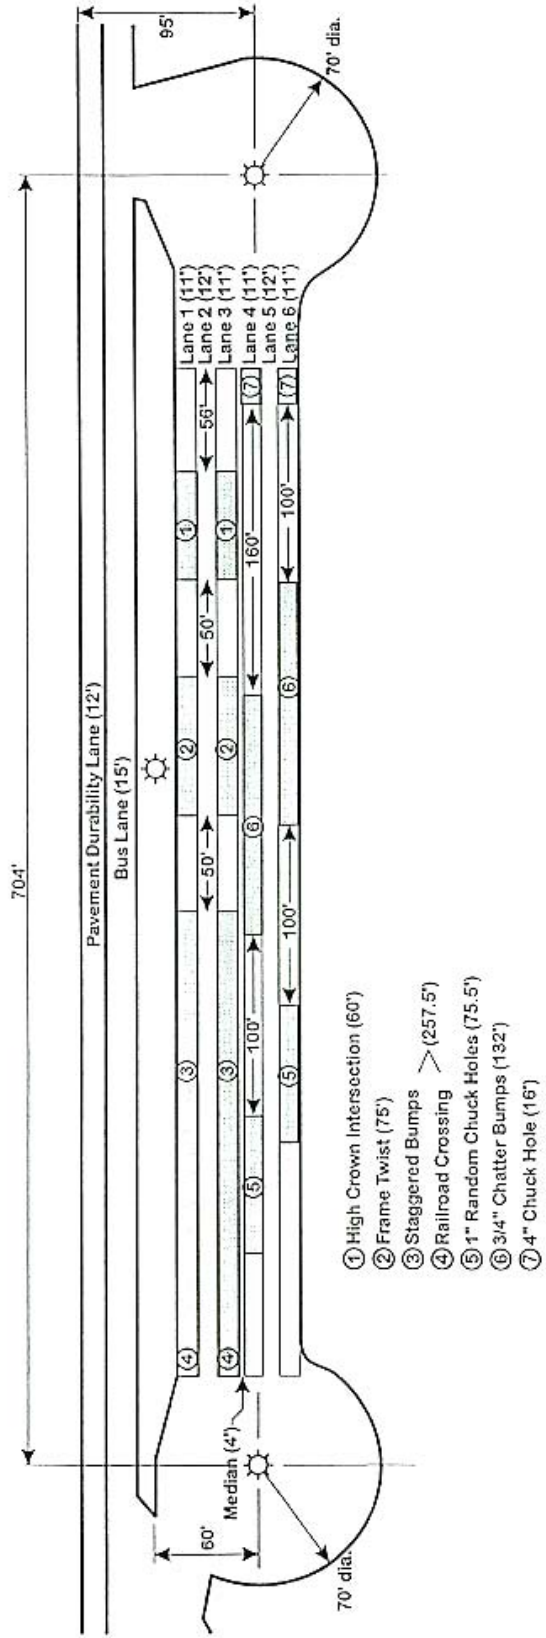
Plan View

- ① High Crown Intersection (60')
- ② Frame Twist (75')
- ③ Staggered Bumps
- ④ Railroad Crossing
- ⑤ 1" Random Chuck Holes (75.5')
- ⑥ 3/4" Chatter Bumps (132')
- ⑦ 4" Chuck Hole (16')

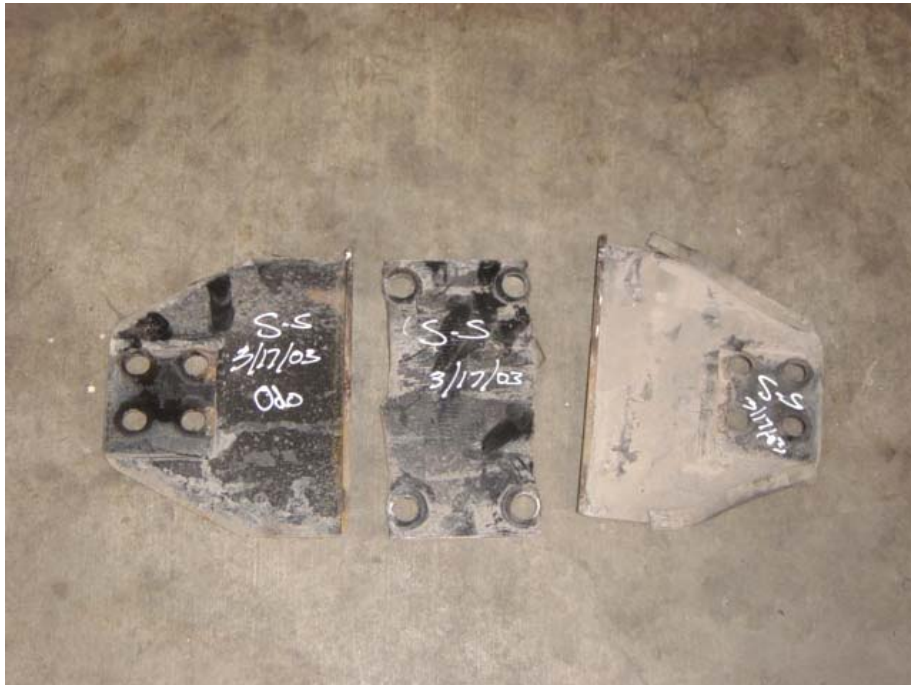
**BROKEN REAR SPRING HANGER  
CROSS MEMBER END BRACKETS  
(4,267 TEST MILES)**

<b>DATE</b>	<b>TEST MILES</b>	<b>SERVICE</b>	<b>ACTIVITY</b>	<b>DOWN TIME</b>	<b>HOURS</b>
02-12-03	260	The dash lights are inoperative.	5 amp fuse is missing from the fuse panel—5 amp fuse installed.	0.50	0.50
02-12-03	260	Inspect for a noise in the front suspension.	Loose front sway bar link bracket bolts torqued.	0.50	0.50
02-13-03	529	The front sway bar link bracket bolts are loose.	Torqued bolts on the front sway bar link bracket.	1.00	1.00
02-14-03	688	The front sway bar link bracket bolts are loose.	Nylok nuts installed on front sway bar link bracket bolts.	0.50	0.50
02-21-03	1,635	No heat in the rear of the bus.	The fan motor in the rear floor heater came loose and broke the fan blades. Broken fan blades removed. Parts ordered.	0.50	0.50
02-27-03	1,780	New fan blades that were ordered on 02/21/03 arrived.	Installed new fan blades in rear floor heater.	0.50	0.50
03-17-03	4,267	The end brackets on the cross member located between the rear spring hangers are broken.	Both end brackets replaced.	1.50	1.50

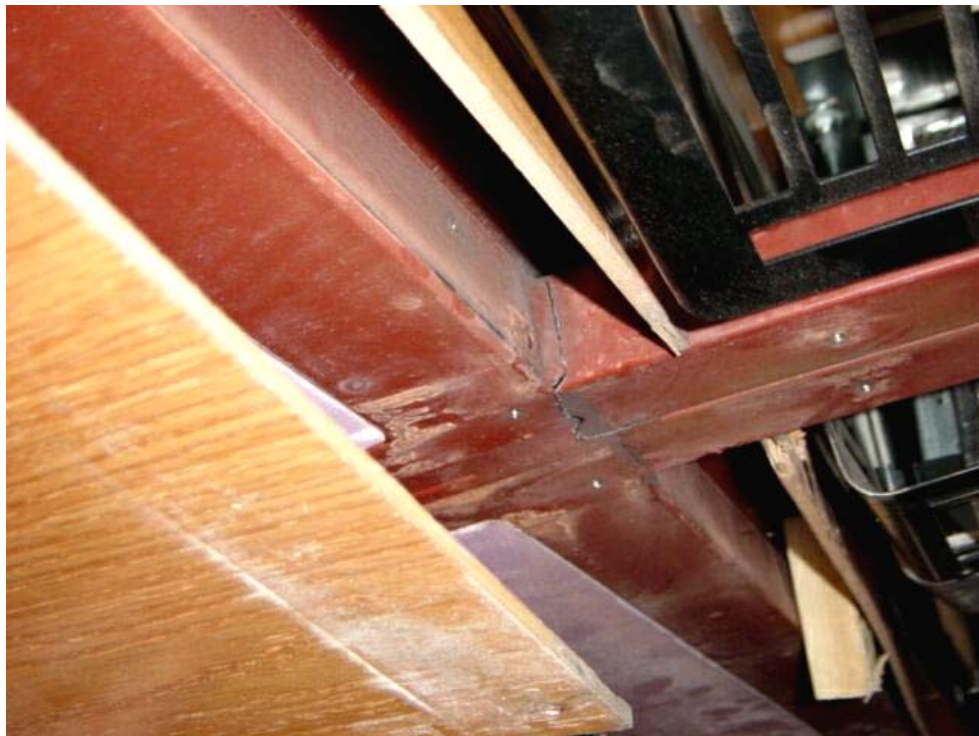
**CRACKED ROOF FRAME AROUND THE A/C UNIT  
(5,927 TEST MILES)**

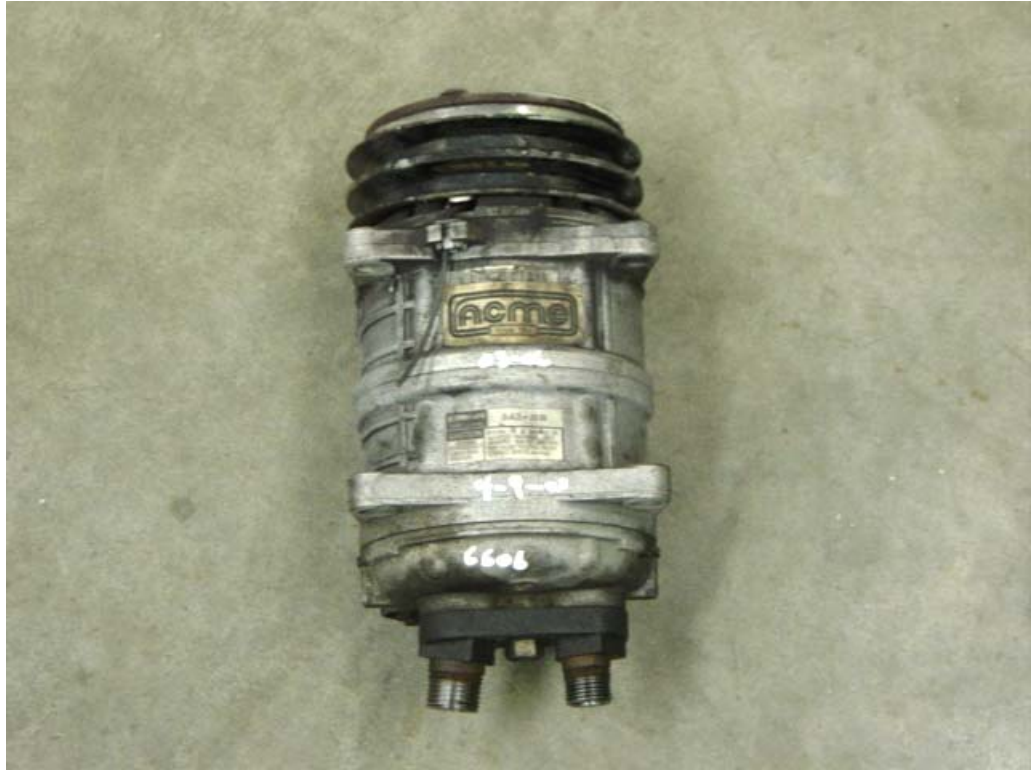
**FAILED A/C COMPRESSOR CLUTCH  
(6,217 TEST MILES)**

<b>DATE</b>	<b>TEST MILES</b>	<b>SERVICE</b>	<b>ACTIVITY</b>	<b>DOWN TIME</b>	<b>HOURS</b>
03-20-03	4,786	The rear heater blower motor has broken loose damaging the fan blades.	Rear heater blower motor and fan removed.	1.00	1.00
03-20-03	4,786	The left door panel, lower pivot pin is missing.	Lower pivot pin replaced.	2.00	2.00
04-02-03	5,927	The roof frame around the A/C unit has cracked.	Welded and repaired cracks in roof frame.	8.00	8.00
04-03-03	6,027	Test driver noticed smoke coming from the engine compartment. The upper A/C compressor clutch has seized.	Power to both compressors disconnected. Notified warranty dealer.	0.50	0.50
04-04-03	6,101	Both front lower sway bar bushings are worn.	Both front lower sway bar bushings replaced.	2.00	2.00
04-09-03	6,217	The upper A/C compressor clutch has seized (reported on 04/04/03).	Warranty dealer (Thermo King) replaced compressor.	4.50	4.50
